THE RANGE OF ICE THRUSTS AND ICE PILES AS REFLECTED BY ICE SCARS ON TREES GROWING ON THE SHORES OF COASTAL LAGOONS: THE CASE OF THE SZCZECIN LAGOON

GIRJATOWICZ J.P., ŚWIĄTEK M., ŁABUZ T.A., 2024. The range of ice thrusts and ice piles as reflected by ice scars on trees growing on the shores of coastal lagoons: The case of the Szczecin Lagoon. *Quaestiones Geographicae* 43(1), Bogucki Wydawnictwo Naukowe, Poznań, pp. 93–110. 11 figs, 2 tables.

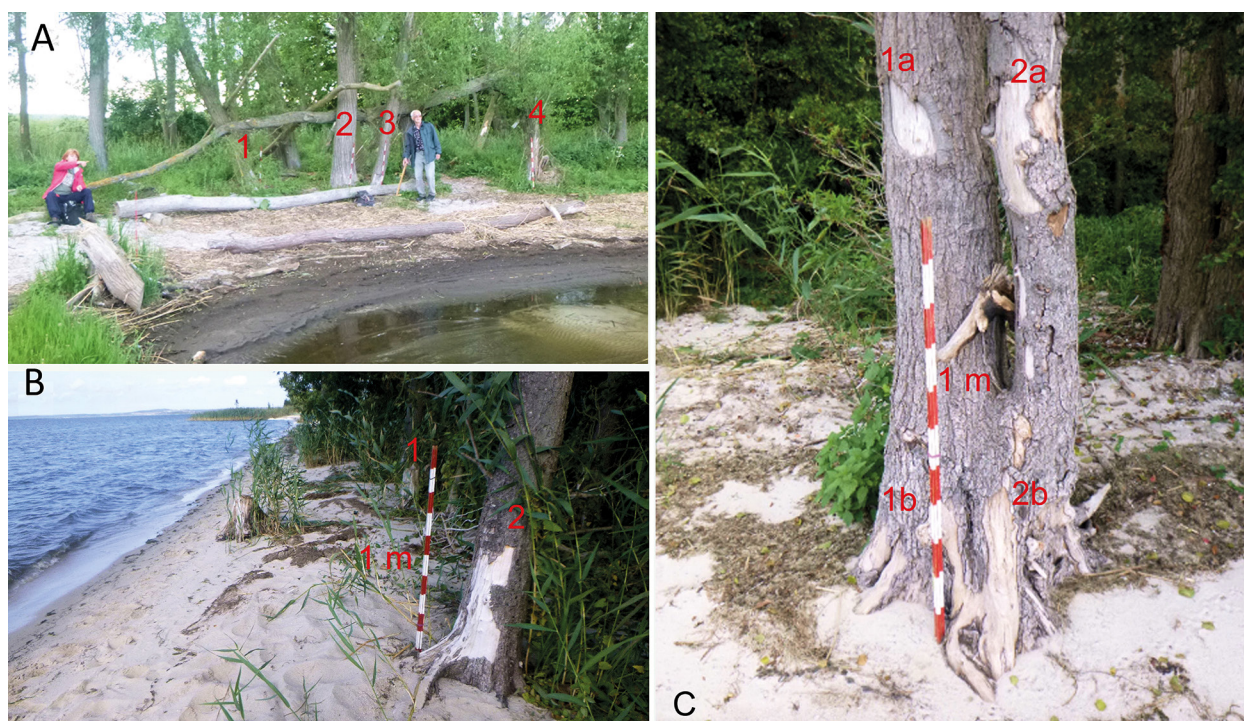
Fig. 2. Examples of ice scars on trees on the lagoon shore. A – a cluster of trees (1–4) bearing ice scars, growing in a small bay, Mönkebude, 25 May 2022; B – trees bearing ice scars (1–2) close to the eroded shoreline, Zagórze, 26 September 2022; C – double scars, Zagórze, 26 September 2022, 1a–1b – north-western thrust direction, 2a–2b – south-western thrust direction.

The segment designated as the eastern shore extends along the coast of the large lagoon, in Poland, north of Kopice, through Czarnocin, the Śmieć Peninsula, Skoszewo, Zagórze, to the western shore of the Rów Peninsula (Fig. 1D). Within this shore segment, approximately 16 km long, it was observed that there were as many as 47 ice scars on trees (Fig. 2B and 2C). Scars on fallen trees, or those eroded away from the substratum, were not measured. The elevations of the shores on which the scarred trees are growing are rather variable, ranging from 0 to 1.6 m a.w.l. (on average 0.4 m a.w.l.). The lowest shores are found on the Rów Peninsula: their elevation is below about 0.5 m a.w.l. Very low shores extend between Czarnocin and Skoszewo. A broad reed belt occurs at many points over this stretch of the shore. Trees growing within this reed belt bore no ice scars. The broadest reed belt occurs adjacent to the Śmieć Peninsula. The eastern part of the lagoon is exposed to frequent and strong wind blowing from the western sector, characterised by a long fetch. The highest ice hummocks develop there from a relatively thick ice floe. The ice floe advances the furthest inland in this low and flat, marshy area from different direction (Fig. 2C).

trunk (Fig. 2C) but formed by ice advancing in different directions.

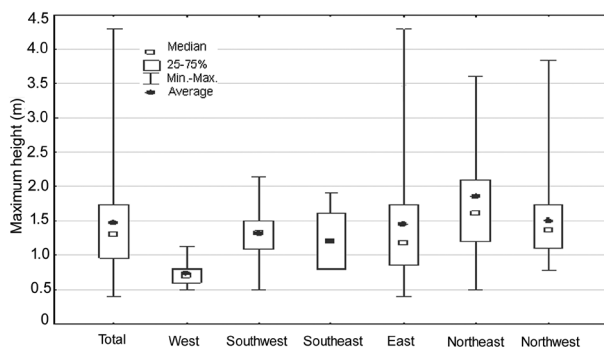
Fig. 6. Quartiles, extremes and average values of the heights for ice scars above water level on trees on the entire shore of the lagoon (Total, *T*) and in its separated parts.

quartiles for the maximum ice scar elevation. The results, along with mean and extreme values, are presented in Figure 6.

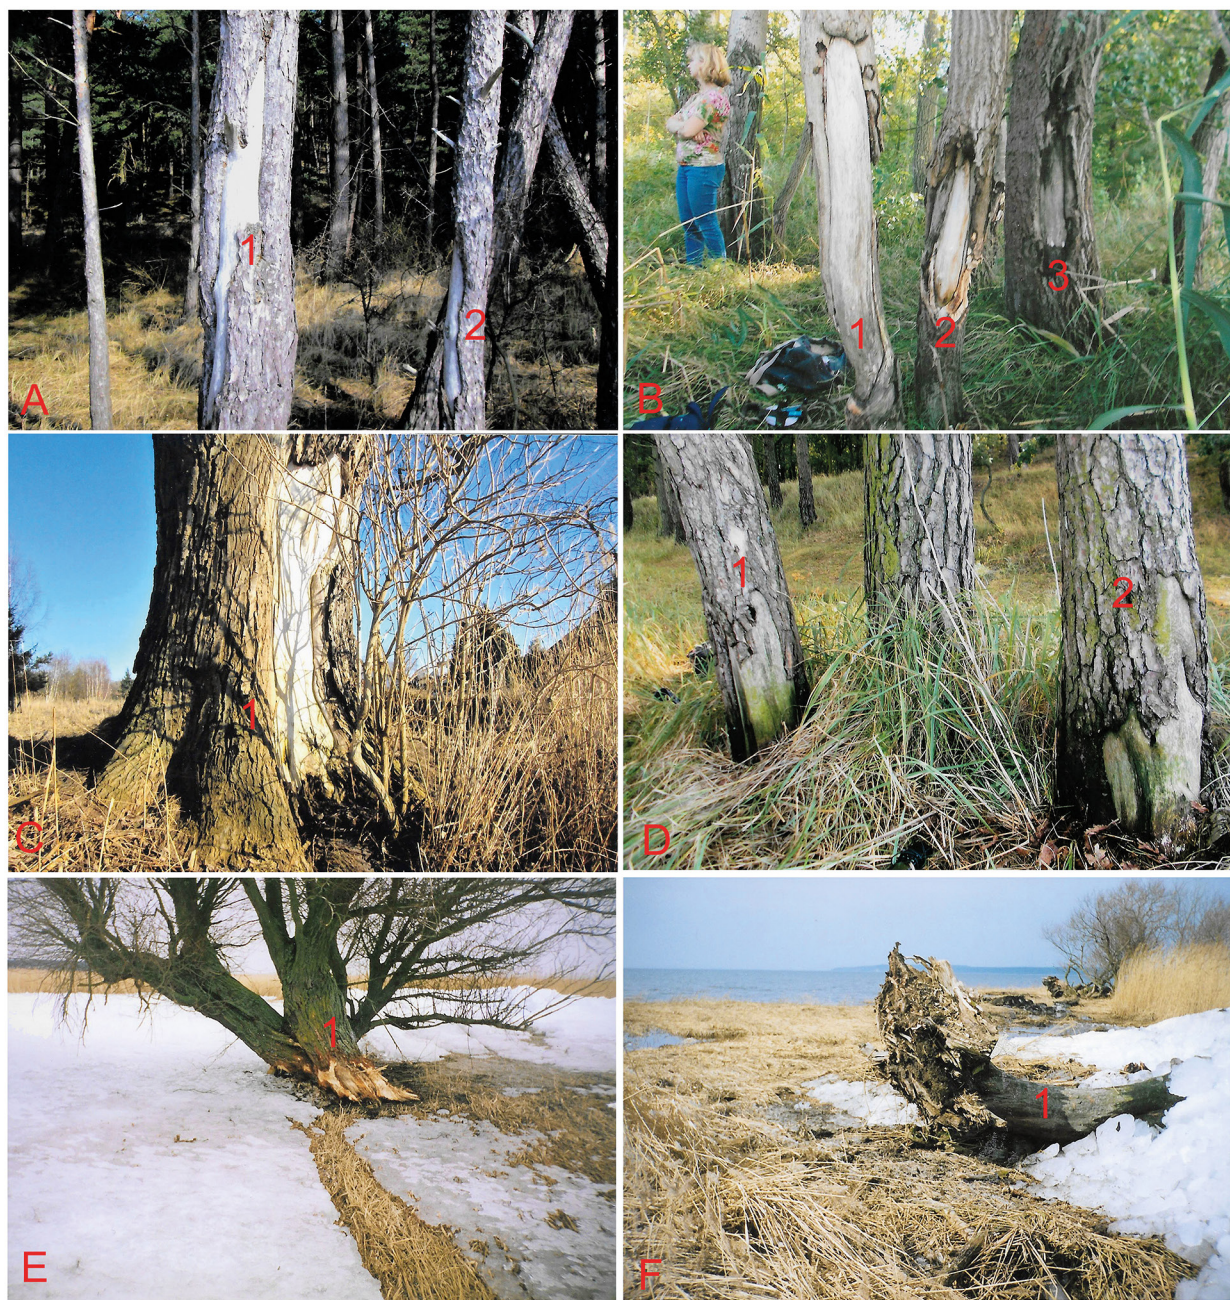
Fig. 7. Examples of ice scars on trees on the Lagoon shore: high-lying and long (A, B), low-lying and long (C), low-lying and short (D, E), on an ice-fallen tree (F). A – pines, north-eastern shore, Karnocice, 13 March 2017; B – poplars, south-western shore, Bellin, 29 September 2020; C – poplar, eastern shore, Kopice, 15 February 2017; D – pines, south-western shore, Altwarp Siedlung, 29 September 2020; E – willow, eastern shore, Rów Peninsula, 18 March 2003; F – willow, eastern shore, Rów Peninsula, 18 March 2003.

The scar that occurred at the highest elevation (4.3 m a.w.l.) was measured on the eastern shore of the lagoon, in Kopice. It formed on a poplar tree growing on a scarp at 1.6 m a.w.l. and 11.5 m from the shore. Two more ice-scarred poplar trees grew next, with scars positioned at 2.7 and 3.9 m a.w.l. The azimuth of the scar (250°) indicates it was formed during a period of wind blowing from the western sector (SW–W). The highest average ice scar elevations were observed in the north-eastern segment of the lagoon shore. The highest of these (3.6 m a.w.l.) was measured in Karnocice, on a pine tree growing on a scarp elevated 1.4 m a.w.l. and 8 m from the shore. Next to it, there was another pine tree bearing an ice scar at an elevation of 3 m a.w.l. (Fig. 7A).

Ice scar lengths and widths were also measured during fieldwork. The length of ice scars on trees around the Szczecin Lagoon varied within a broad range, from 9 to 280 cm (Fig. 7). The largest tree ice scars, both with respect to maximum width and length, were observed on the eastern shore of the lagoon (Fig. 8). In the remaining segments of the lagoon shore, the scars had similar dimensions.

growing on a ground elevated 0.5 m a.w.l., 18 m from the shore. The remaining ice scars on the Rów Peninsula were also rather wide, from 30 to 60 cm. One of these is pictured in Figure 7F. It was found that the azimuth of these scars displayed a remarkably broad range, from 210 to 340°.
